ASSESSMENT OF FAILURES OF POST-FRAME BUILDINGS IN NEW YORK STATE DUE TO SNOW LOAD

C.A. Gooch, P.E. and K.G. Gebremedhin
Senior Extension Associate and Professor, respectively, Dept. of Ag. & Bio. Eng.
Cornell University, Ithaca, NY 14850

Written for Presentation at the
1999 ASAE/CSAE-SCGR Annual International Meeting
Sponsored by ASAE

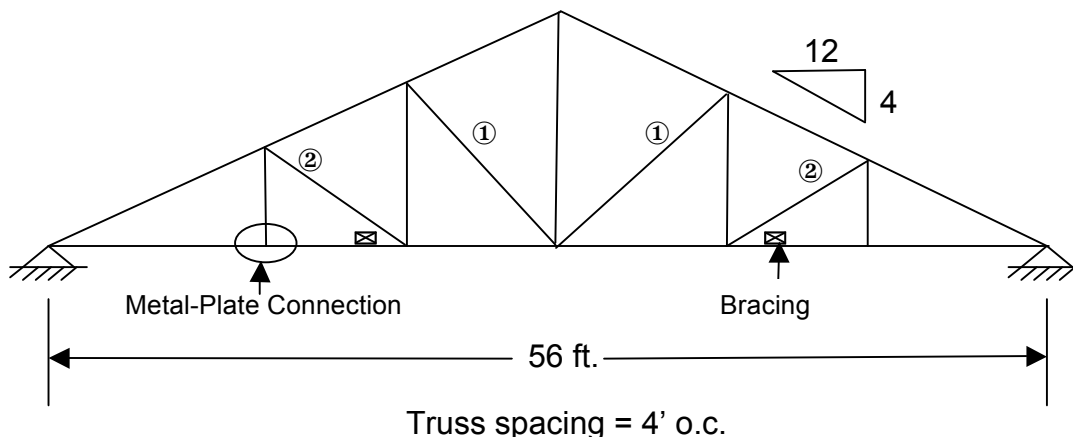
Figure 2. Truss configuration of the original truss for Case No. 1.

Based on significant visible lateral deflections of the compression web and bottom chord members of the trusses in the original building, the fire department was called in to shovel the roof. Twenty to thirty men worked for several hours to remove snow from the roof. A large volume of snow on the upper roof was transferred to the lien-to addition roof causing increased loading. A barn employee recalled hearing creaking and groaning in the area of the lien-to addition and reported this to the shoveling crew. Efforts were re-directed towards shoveling snow from the lien-to roof and it was saved.

The truss configuration of the original building is shown in Figure 2. Top and bottom chords were 2x8's and web members were 2x4's. Trusses were spaced 4 ft. on center. The owner commented that the web members marked ① deflected approximately one foot out-of-plane and those members marked ② also deflected significantly. The calculated slenderness ratios for the web members marked ① and ② are 90 and 79, respectively. These values exceed the allowable limit of slenderness ratio of 50 (National Forest Products Association, 1991). Lateral bracing of these members would be appropriate to reduce the unsupported buckling length.

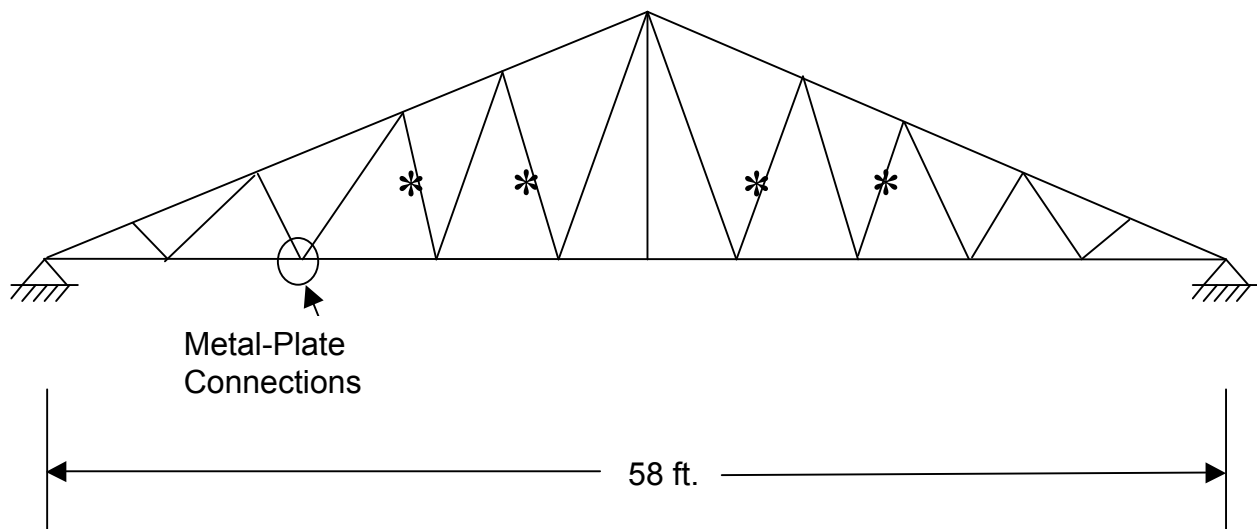
Figure 3. Truss configuration of new addition for Case No. 1.

The truss configuration of the new addition is shown in Figure 3. Top chords are 2x12's, bottom chords are 2-2x6's stacked on edge, starred (*) web members are 2-2x6's and the rest are 2x4's. These trusses were spaced 10 ft. on center. Visual observation showed that the trusses lack bottom chord, web, and diagonal bracing members.

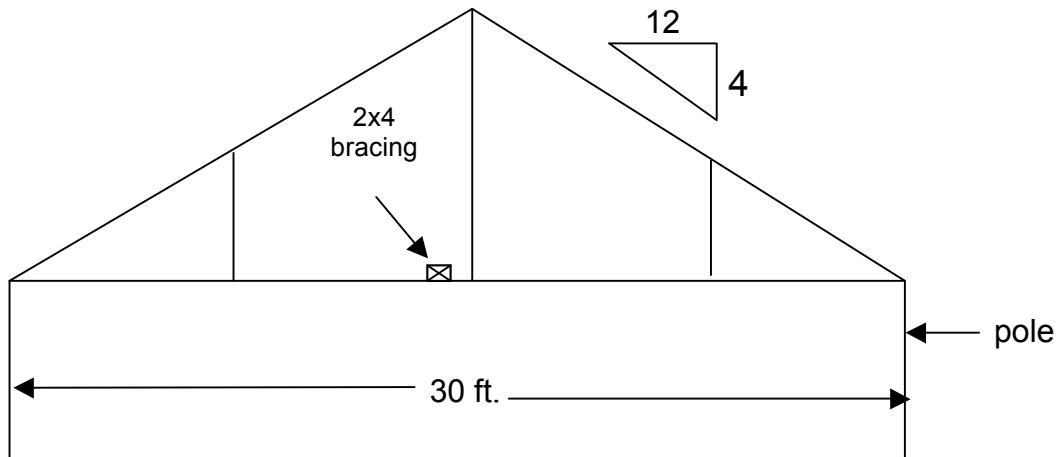
Figure 4a. Truss configuration for Case No. 2.

In the original truss configuration, under ideal vertical conditions of the truss, the center and the other two vertical web members are zero force members (Figure 4a). This means that no force is transferred by these members from the top chord to the bottom chord. Hence, the truss can be considered as one big triangle.

The remedy employed by the building owners changed the load transfer mechanism of the trusses. By placing the 2-ply posts directly under the center vertical web member, the center web member now carries the sum of the vertical components of the top chords at the ridge. This puts the center web member in compression, a load that it was not originally designed to carry.

The bottom chord lateral bracing was originally at mid-span only and was not moved after the center posts were put in place. No diagonal bracing existed on the roof.

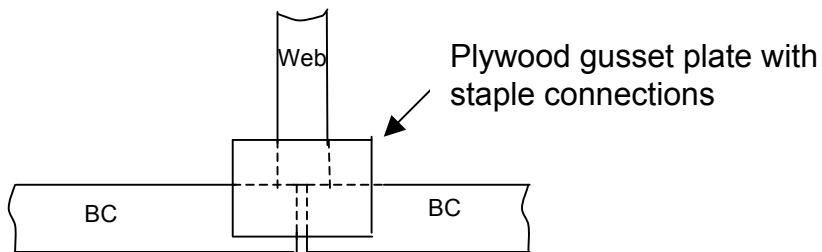
Figure 4b. Bottom chord connection for Case No. 2.

to deflect about one foot downward at mid-span. Noticeable was the large gap that developed between the butted ends of the two members forming the truss bottom chords. The connection at the butted ends was a wooden gusset plate located at mid-span.

The tension splice of the bottom chord was at mid-span of the truss. The strength of the connection was entirely dependent upon a few nails connecting the gusset plate to the bottom chord, and the strength of the nails was compromised by corrosion because of the moisture-laden environment.

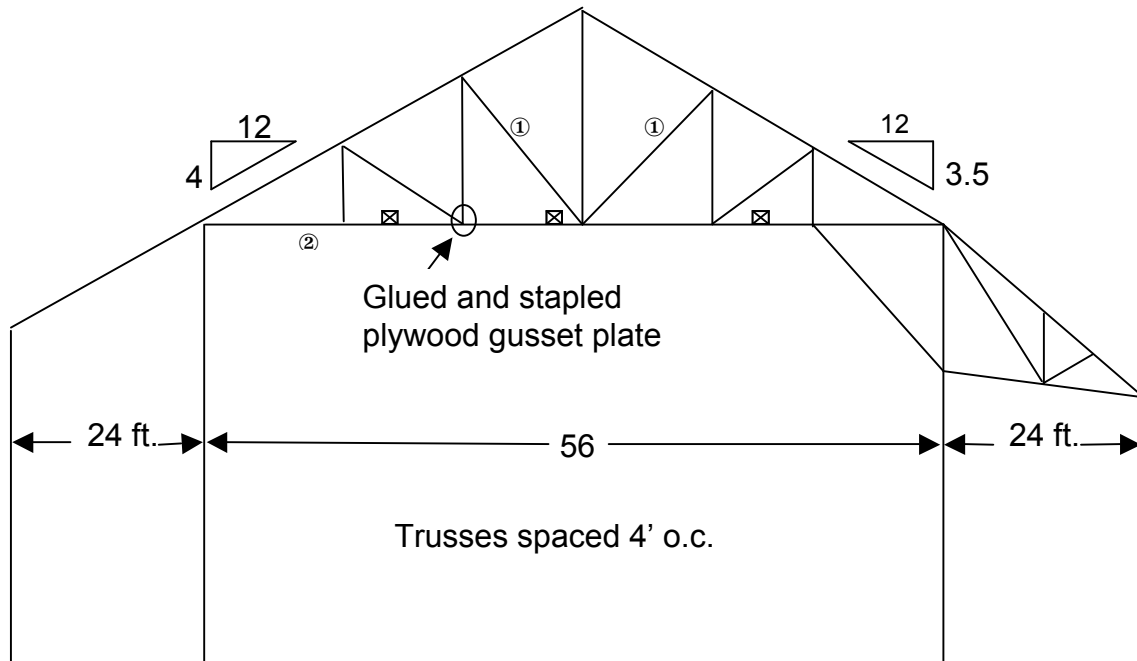
Figure 5. Truss configuration for Case No. 3.

The collapse of the trusses seemed to have originated at the web members marked ①. These members failed by buckling under the heavy snow load. The connections marked ② on Figure 5 were also separated. The slenderness ratios of the compression web members marked ① were greater than 50. Installation of appropriate lateral bracing on these members would have reduced the buckling length to an acceptable value. The owner of the building indicated to us that they had constructed the original building with farm labor.

The producer expressed his disappointment about the failed building, yet he failed to recognize the need to install lateral bracing in the new trusses despite the fact that he was provided instructions by the truss manufacturer describing how to do so. Again farm labor was used to set the trusses and make repairs.

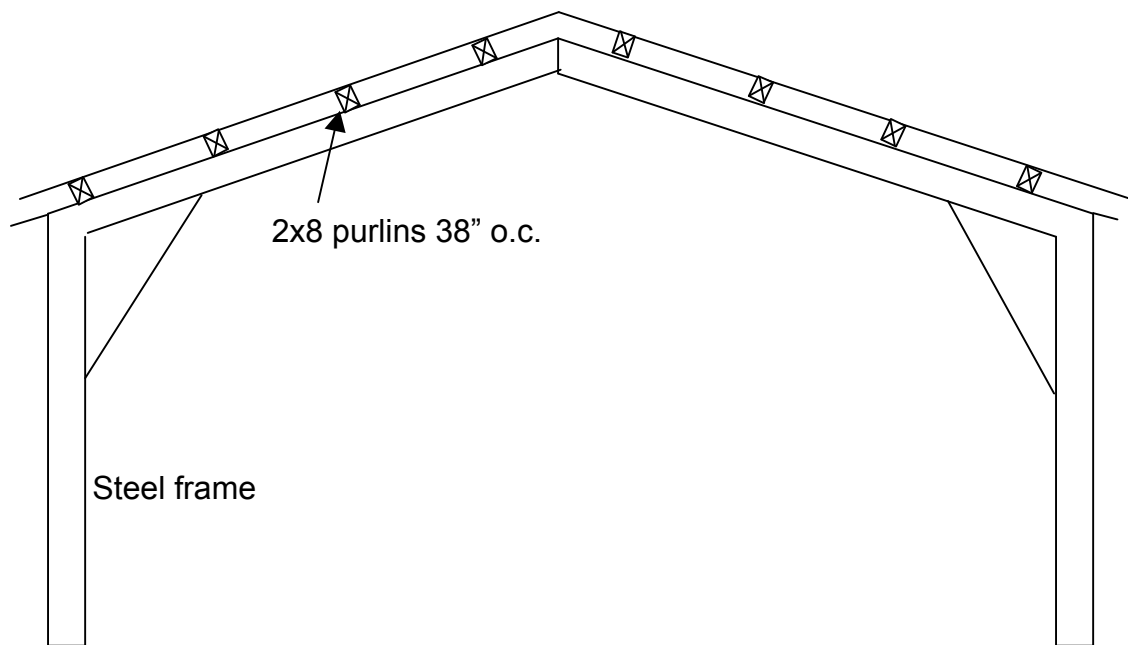
Figure 6a. Building cross-section for Case No. 4.

This building was a pre-engineered steel structure built in 1970 and was used as a freestall cow barn (Figure 6a). The barn had a north-south orientation. Although it was a steel frame building, 2x8 wood purlins, spaced 38 in. o.c., were installed on edge in lieu of steel purlins. The wood purlins clear spanned 16 ft. The measured sidewall height was 9 ft.

This building lacked any meaningful ventilation system. Consequently, a high-moisture environment existed in the barn. The purlins were visibly wet. Reportedly, the original galvanized roof had been replaced in 1987 due to advanced rusting.

The snowstorm resulted in an unbalanced snow load on the structure. There was heavy snow accumulation on the east-facing roof. Failure was avoided by shoveling snow off the roof. The owner noticed visible deflections of the purlins and consequently decided to remove the snow.

A mechanical or natural ventilation system should be installed in the barn to improve air ventilation. The orientation of the barn provides the opportunity to take advantage of the prevailing westerly winds but the relatively low sidewall height may not allow sufficient air to enter the building. A mechanical ventilation system would be more effective in this building. Plans should also be made to either replace the existing wood purlins with engineered metal purlins or install new intermediate wood purlins. The existing purlins (Figure 6b) given their size (2x8), span (16 ft.), spacing (38 in. o.c.) and in service condition (wet) are far from being adequate for the design load.

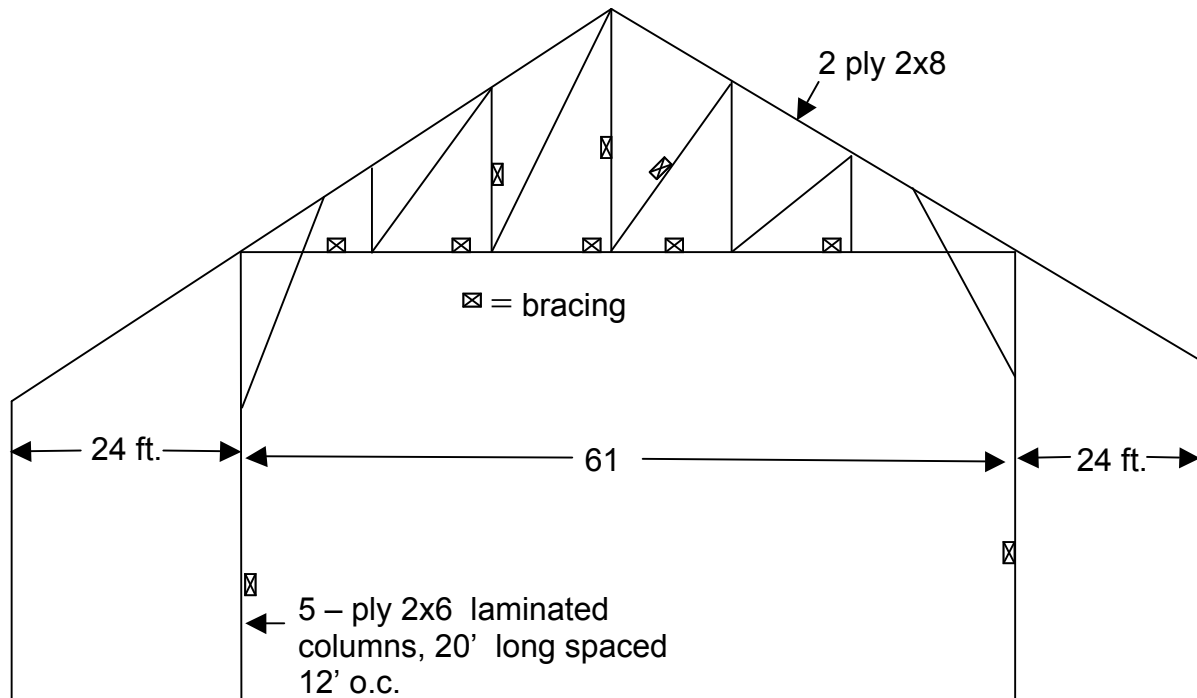
Figure 7. Typical cross-section of Case No. 5.

The building was well braced as shown in Figure 7. The bottom chords had sufficient lateral bracing members, and all long compression web members were adequately braced laterally. One end of each knee brace was connected to an intermediate post and the other end extended up to the truss top chord where it was properly connected.

Careful investigation of the remains of the failed laminated post showed that the center ply had a large knot located at the location of apparent failure. The posts were not laterally braced along the weak axis. Because of the visible buckling observed by the owner during the snowstorm, he braced the interior posts laterally subsequent to the failure of the one post. It seems that the post with the large knot failed and pulled down on the truss that was connected to it. A split across the holes of the truss-to-post

connectors (bolts) was visible perhaps due to racking effect. Nevertheless, the building appeared to be well designed as was exhibited by the fact that the failure was contained within one post/truss assembly.

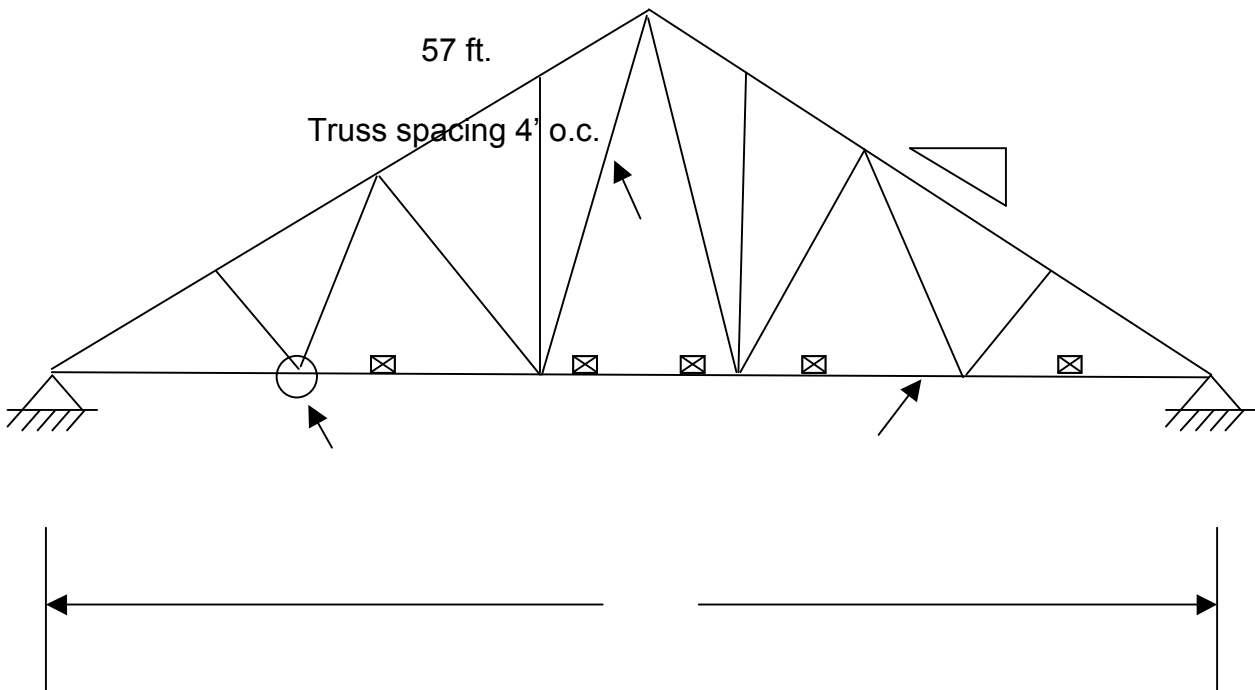
Figure 8. Original center truss configuration for Case No. 6.

The configuration of the original center truss is shown in Figure 8. The truss spacing was 4 ft. o.c. The bottom chords were adequately braced laterally, but the compression web members were not.

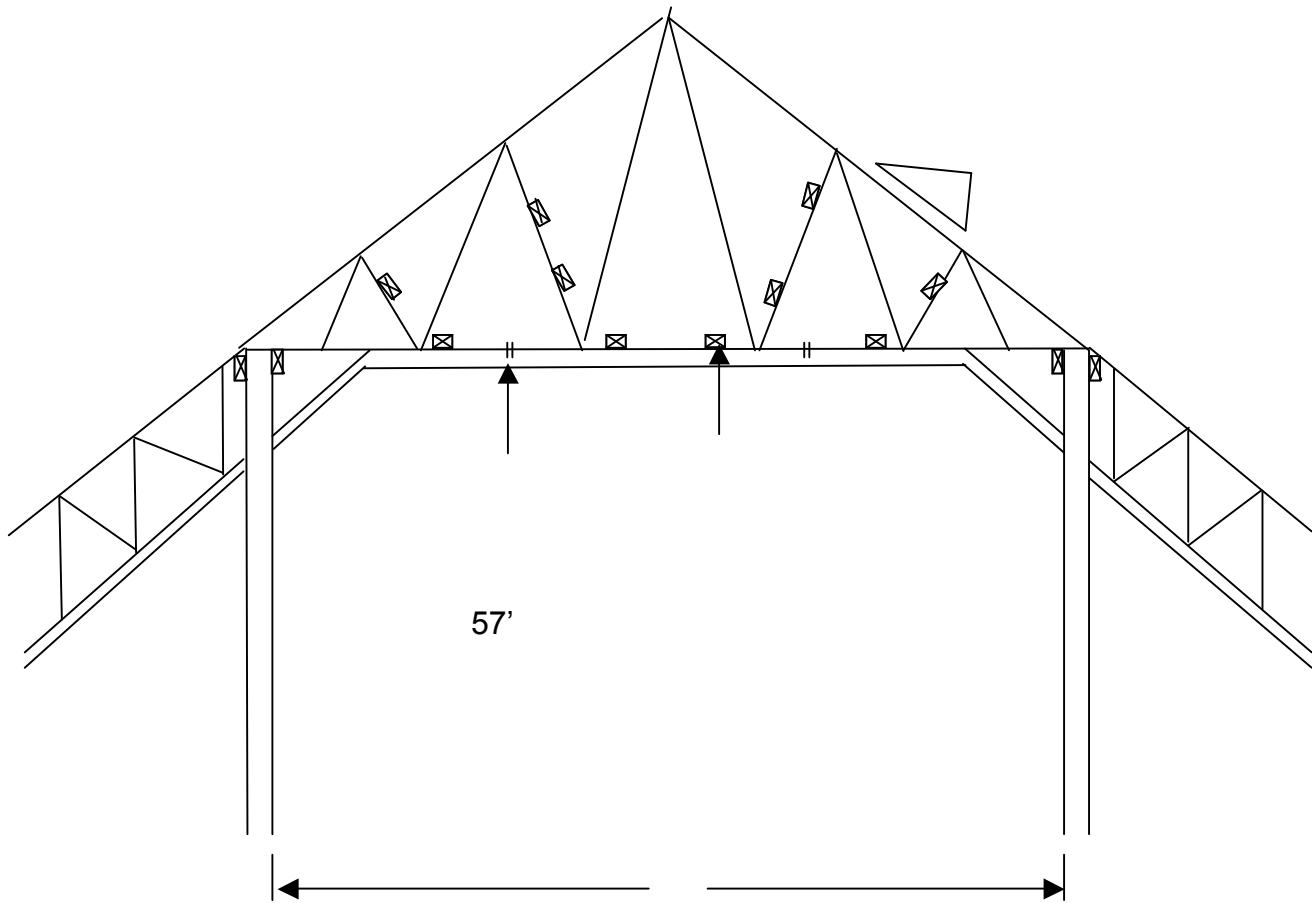
Figure 9. Replacement truss configuration for Case No. 6.

The configuration of the replacement trusses are shown in Figure 9. The new trusses were spaced 2.67 ft. on center (3 trusses per 8 ft.). Bottom chord, top chord, and web members were 2x6's, 2x8's, and 2x4's, respectively. Many of the new trusses were only toe-nailed to the horizontal header running between the posts. This type of connection may prove to be inadequate to withstand uplift forces caused by wind. Also, gaps between insulation boards (because of improper installation) will allow moisture migration to the attic space and become trapped within. As previously mentioned, this situation may be detrimental to the strength of the wood and the integrity of the connection as well as the deterioration of the insulation.

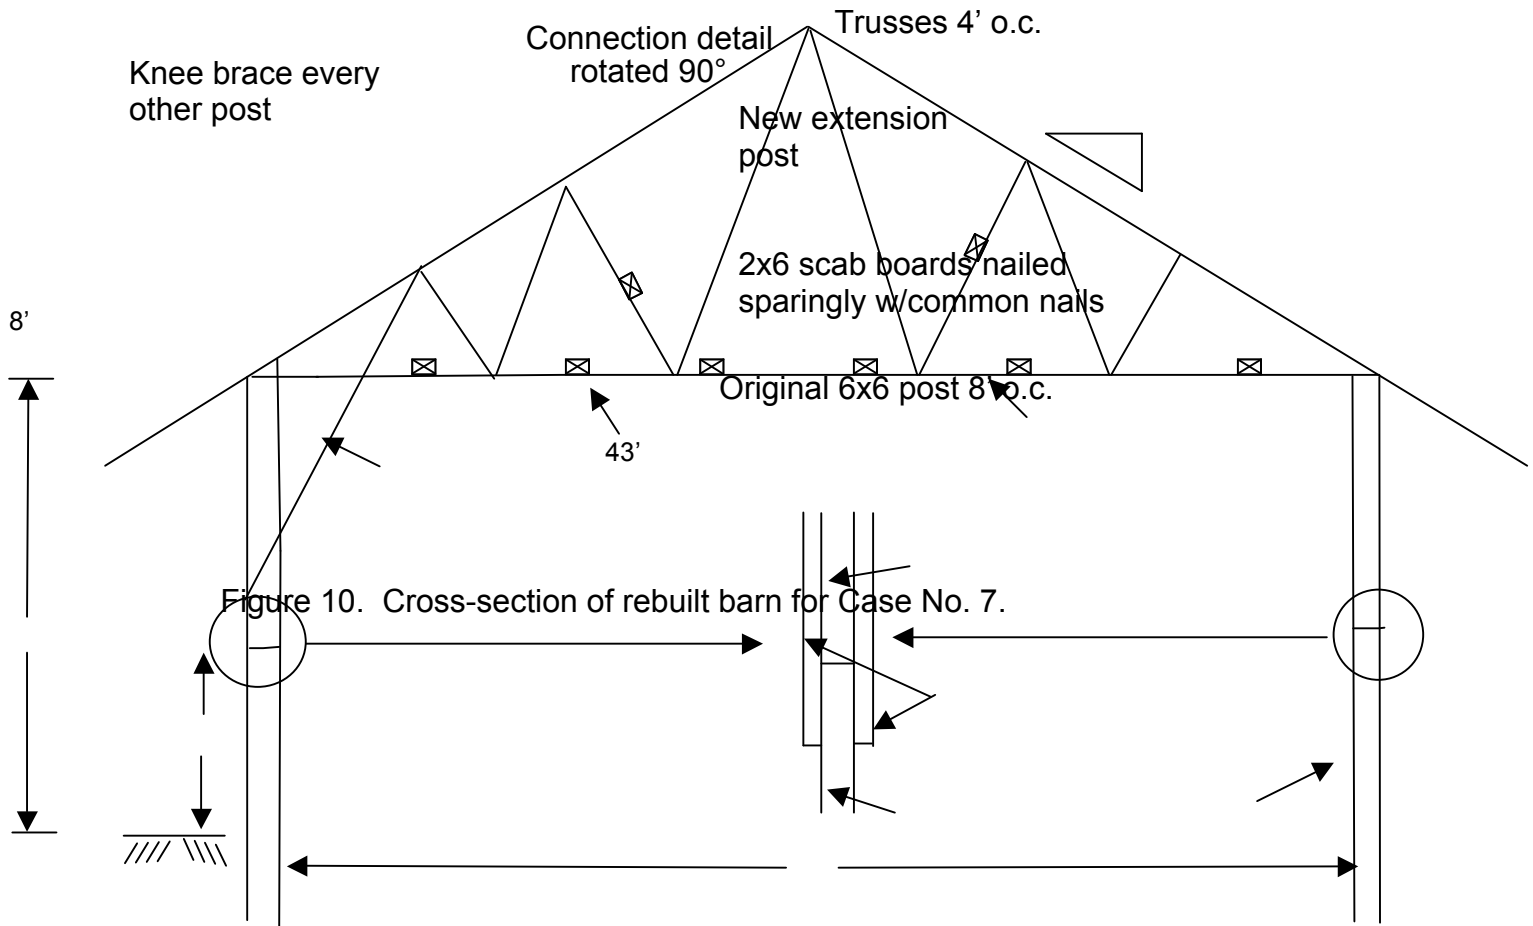
As stated previously, the original 8 ft. high posts were extended to 14 ft. To increase the sidewall height by 6 ft., a new 6x6 post was placed on top of the original 6x6 post and held in place by two - 2x6 scab boards nailed sparingly to the post with common nails. The method of connection and the materials used is marginal at best.

The new posts used on the left wall of the building extended all the way to the top chord and the trusses were face nailed to the posts. The posts on the right wall however, were not extended to the top chords. The trusses on this side of the building are toe nailed to the header. From casual observation, the latter connection seems to be inadequate to resist uplift forces.

The connection of the intermediate trusses on the left wall consisted of face nailing the truss to an intermediate stub block. The stub block was securely fastened to the header with multiple nails. On the right wall, however, trusses were merely toe nailed to the header as no stub blocking was installed.
